FACILITY CONDITION ASSESSMENT

July 2, 2018

SKYLINE HIGH SCHOOL
2552 NORTH MAPLE ROAD
ANN ARBOR, MICHIGAN 48104

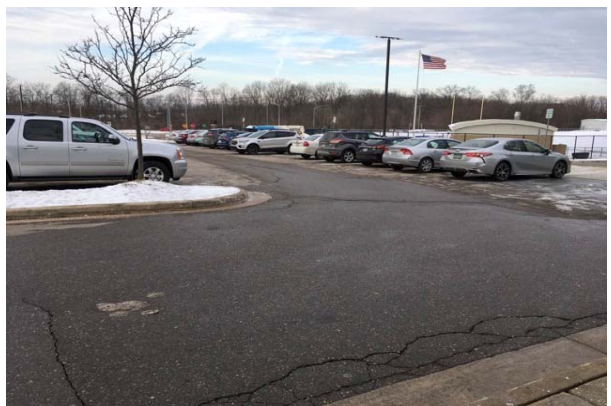
#6:	PARKING LOT
-----	-------------

Site : The asphalt parking and drive lanes are generally in fair/ poor condition. A cost allowance to repair and /or replace these deficient attributes is included in the cost tables.

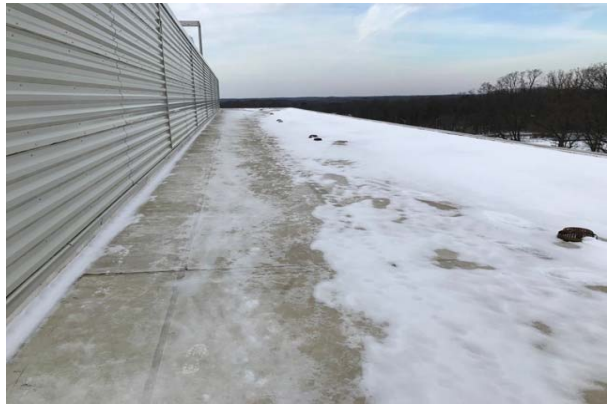
#22:	ROOF
------	------

- The roof finishes were installed in 2008 appear to be original. Information regarding roof warranties or bonds was not available.
- Roof leaks have occurred in the past year. The leaks have since been repaired, and no active roof leaks are evident.
- There is no evidence of roof deck or insulation deterioration. The roof substrate and insulation should be inspected during any future roof repair or replacement work.

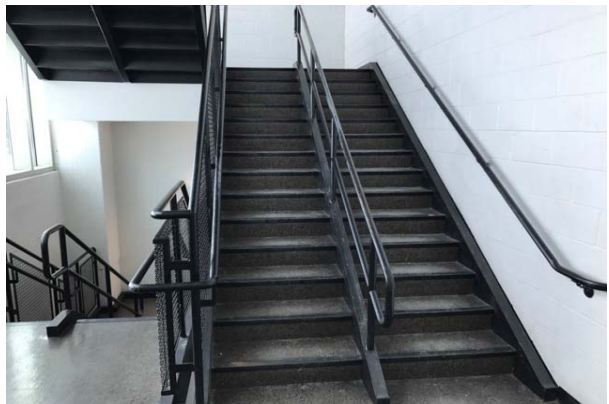
#24:	INTERIOR STAIRS
------	-----------------

Architectural : The interior walls in two stairwells (North side and west side) have cracks in the masonry running in a vertical direction. A cost allowance to repair and paint these deficiencies is included in the cost tables. It was noted by staff that water is leaking in several areas of the building. It was not possible to determine if it was from the exterior or interior.

- The foundations and footings cannot be directly observed. However, there are isolated areas of cracking, movement, and vertically displaced slabs observed in the southwest back stairwell. . This condition typically indicates excessive settlement or other potential problems with the foundation system. A Professional Engineer with specific expertise in structural design and construction in this geographical area must be retained to evaluate the structure and to provide remedial recommendations consistent with local regulatory and code requirements. Although the estimated cost of repair cannot be accurately determined without the recommended study, a budgetary cost allowance to repair the affected elements is also included.
