FACILITY CONDITION ASSESSMENT

SCARLETT MIDDLE SCHOOL
3300 LORRAINE STREET
ANN ARBOR, MICHIGAN 48108

January 24, 2018

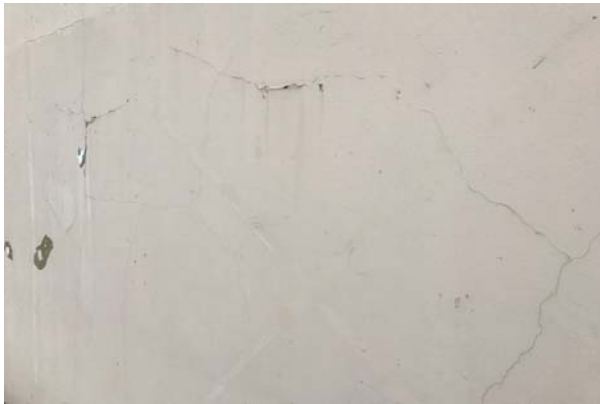
#9:	CONCRETE FACADE
-----	-----------------

- The concrete walls have significant areas of cracked and damaged concrete consistent across all building elevations. The damaged concrete must be repaired as part of the preparation for exterior painting. The associated costs for repairs and painting are included in the cost tables.
- Isolated portions of the mortar joints along the brick veneer are degraded, particularly on the rear elevation of the building. The damaged mortar joints must be cleaned and re-pointed.
- On-going periodic maintenance, including patching repairs, graffiti removal, and re-caulking, is highly recommended. Future lifecycle replacements of the components listed above will be required.

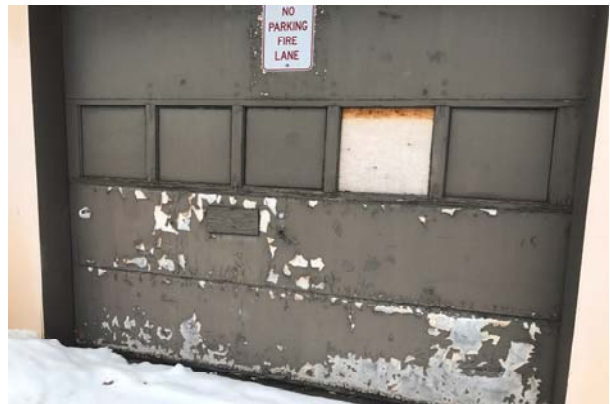
#12:	OVERHEAD DOOR
------	---------------

- The overhead doors at the loading dock on the left elevation of the building are in poor condition and should be replaced immediately.
- No other significant actions are identified at the present time. On-going periodic maintenance is highly recommended. Future lifecycle replacements of the components listed above will be required.

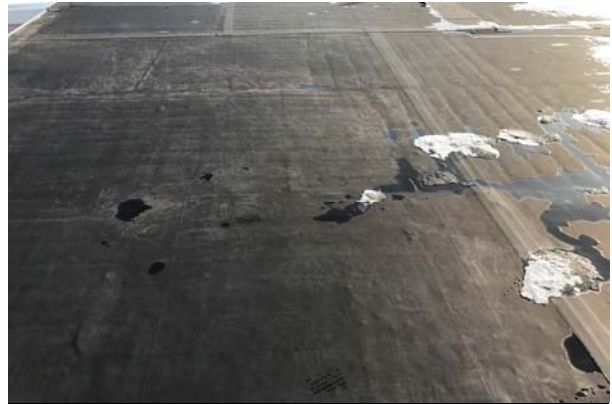
#14:	EPDM ROOFING
------	--------------

- According to the POC, there are no active roof leaks. There is no evidence of active roof leaks.
- There is no evidence of roof deck or insulation deterioration. The roof substrate and insulation should be inspected during any future roof repair or replacement work.

- The POC reported that future roof replacement will consist of TPO or PVC membrane in accordance with a district-wide effort to standardize their roofing systems. A future lifecycle replacement reflecting the appropriate roofing system is included in the cost table.

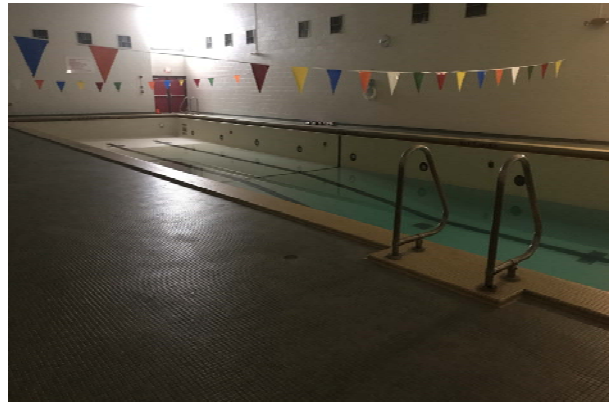
#30:	SWIMMING POOL
------	---------------

Key Spaces Not Observed		
Room Number	Area	Access Issues
Site Locations	Playing fields, Basketball Courts, Tennis Courts	Snowy conditions hindered a thorough, visible inspection
The following down units or areas were observed: The swimming pool is currently not operational for a number of mechanical deficiencies. The school has received a proposal outlining the work necessary to restore the pool to an operational state.

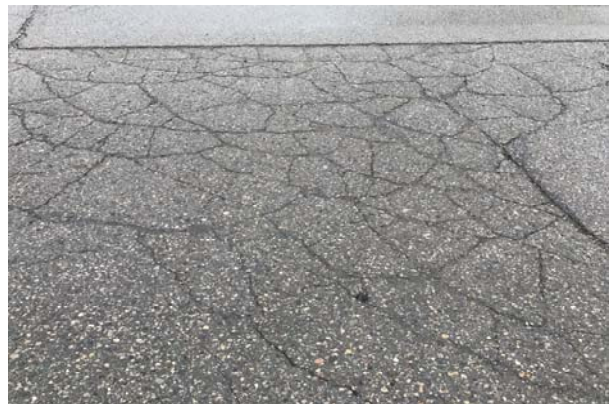
#60:	PAVEMENT CONDITION
------	--------------------

Site : The asphalt parking area and adjacent drive aisles are generally in poor condition. Additionally, much of the concrete sidewalks and curbing are distressed. A cost allowance to repair and/or replace these deficient attributes is included in the cost tables.

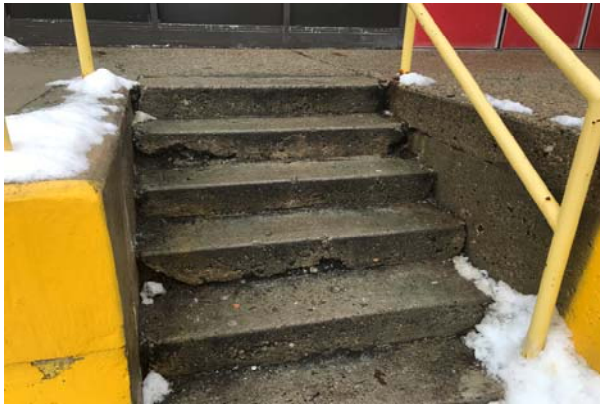
#63:	LOADING DOCK STAIRS
------	---------------------

- No significant actions are identified for the interior stairs at the present time. On-going periodic maintenance is highly recommended.
- The exterior concrete stairs that serve the loading dock on the left elevation of the building have areas of degradation. The damaged portions of the stairs must be repaired. The cost to repair the stairs is relatively insignificant and the work can be performed as part of the property management's routine maintenance program.
