FACILITY CONDITION ASSESSMENT

July 2, 2018

CLAGUE MIDDLE SCHOOL
2616 NIXON ROAD
ANN ARBOR, MICHIGAN 48105

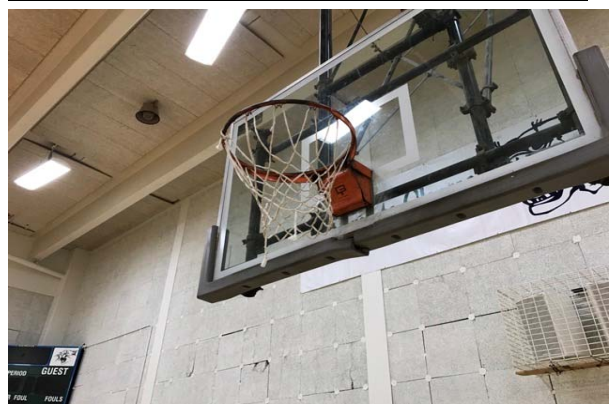
#18:	SPORTS APPARATUS, BASKETBALL BACKSTOP
------	--

- The rims to the basketball backstops are bent in the lower gym. The damaged basketball backstops must be replaced. A cost allowance to replace the basketball backstops is included.

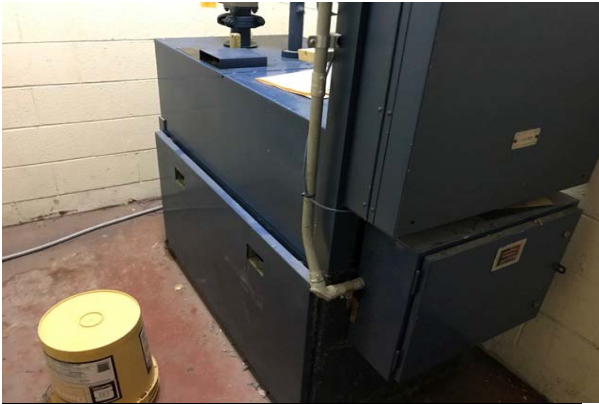
#19:	ELEVATOR
------	----------

- The elevators are serviced by outside contractors on a routine basis. The elevator machinery and controls are the originally installed system.
- The elevators appear to provide adequate service. The elevators are serviced by outside contractors on a routine basis. The elevator machinery and controls are the originally installed system. The elevators will require continued periodic maintenance. Full modernization is recommended. A budgetary cost for this work is included.

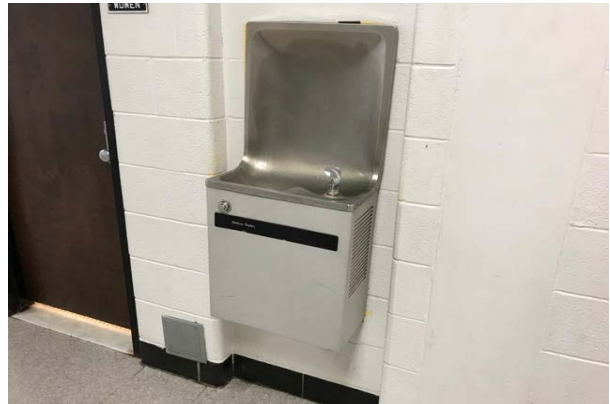
#22:	DRINKING FOUNTAIN
------	-------------------

MEPF : The drinking fountains located in the swimming pool area need to be replaced as they do not work. The vast majority of the building is not protected by fire suppression; sprinkler heads are currently limited to the garage. Due to its construction date, the facility is most likely “grandfathered” by code and the installation of fire sprinklers not required until major renovations are performed. Regardless of when or if installation of facility-wide fire suppression is required by the governing municipality, EMG recommends a retrofit be performed. As part of the major planned, a facility-wide fire suppression retrofit is recommended.

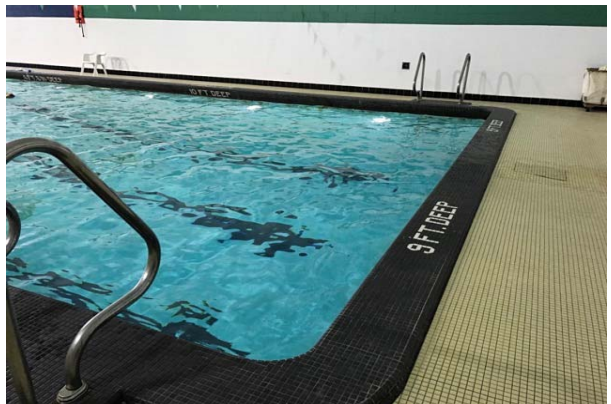
#60:	SWIMMING POOL PLASTER
------	-----------------------

The swimming pool area is in poor condition. There is mold located throughout the acoustic tile ceiling, and tiles or either missing or damaged in the pool. A professional engineer must be retained to analyze the existing condition, provide recommendations and, if necessary, estimate the scope and cost of any required repairs. The cost of this study is included in the cost tables. A cost allowance to repair the acoustic tile ceiling and refinish the swimming pool is also included in the cost tables.

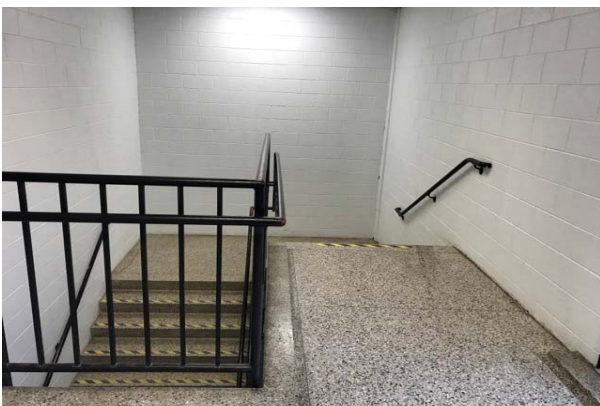
#65:	STAIRWELL
------	-----------

- The concrete interior stairs have significant areas of chipped concrete located throughout the stairwells. The damaged portions of the stairs must be repaired. A cost allowance to repair the interior concrete stairs is included.
- The concrete exterior stairs have significant areas of cracking and rebar is corroding causing rust stains located on the rear elevation of the site. The damaged portions of the stairs must be repaired. A cost allowance to repair the exterior concrete stairs is included.
