FACILITY CONDITION ASSESSMENT

SCARLETT MIDDLE SCHOOL
3300 LORRAINE STREET
ANN ARBOR, MICHIGAN 48108

January 24, 2018

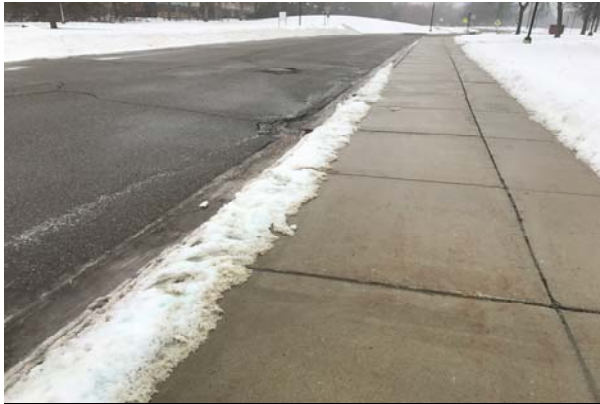
#60:	PAVEMENT CONDITION
------	--------------------
