FACILITY CONDITION ASSESSMENT

SCARLETT MIDDLE SCHOOL
3300 LORRAINE STREET
ANN ARBOR, MICHIGAN 48108

January 24, 2018

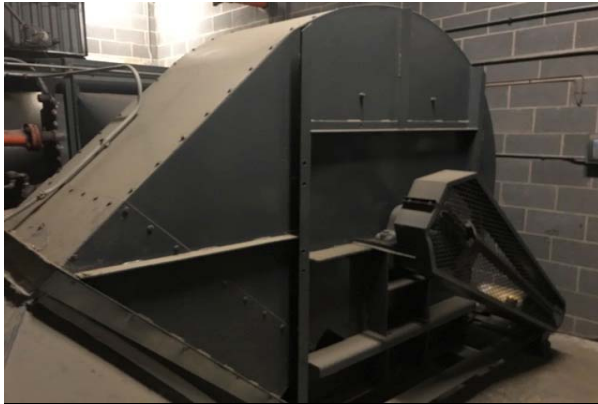
#42:	AIR HANDLER, NEWER
------	--------------------

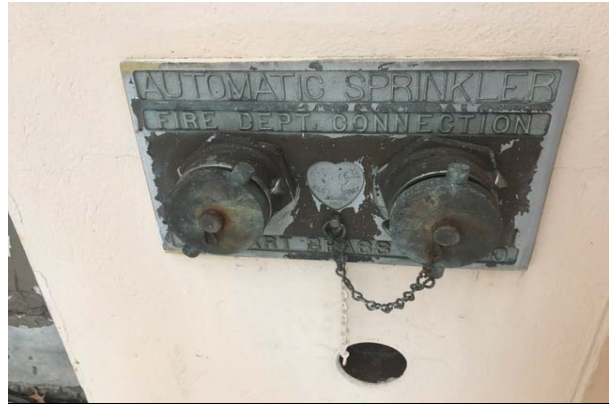
#49:	FIRE SAFETY COMPONENTS
------	------------------------
